PIC18F24K20/25K20/44K20/45K20 Silicon Errata and Data Sheet Clarification

The PIC18F24K20/25K20/44K20/45K20 devices that you have received conform functionally to the current Device Data Sheet (DS41303G), except for the anomalies described in this document.

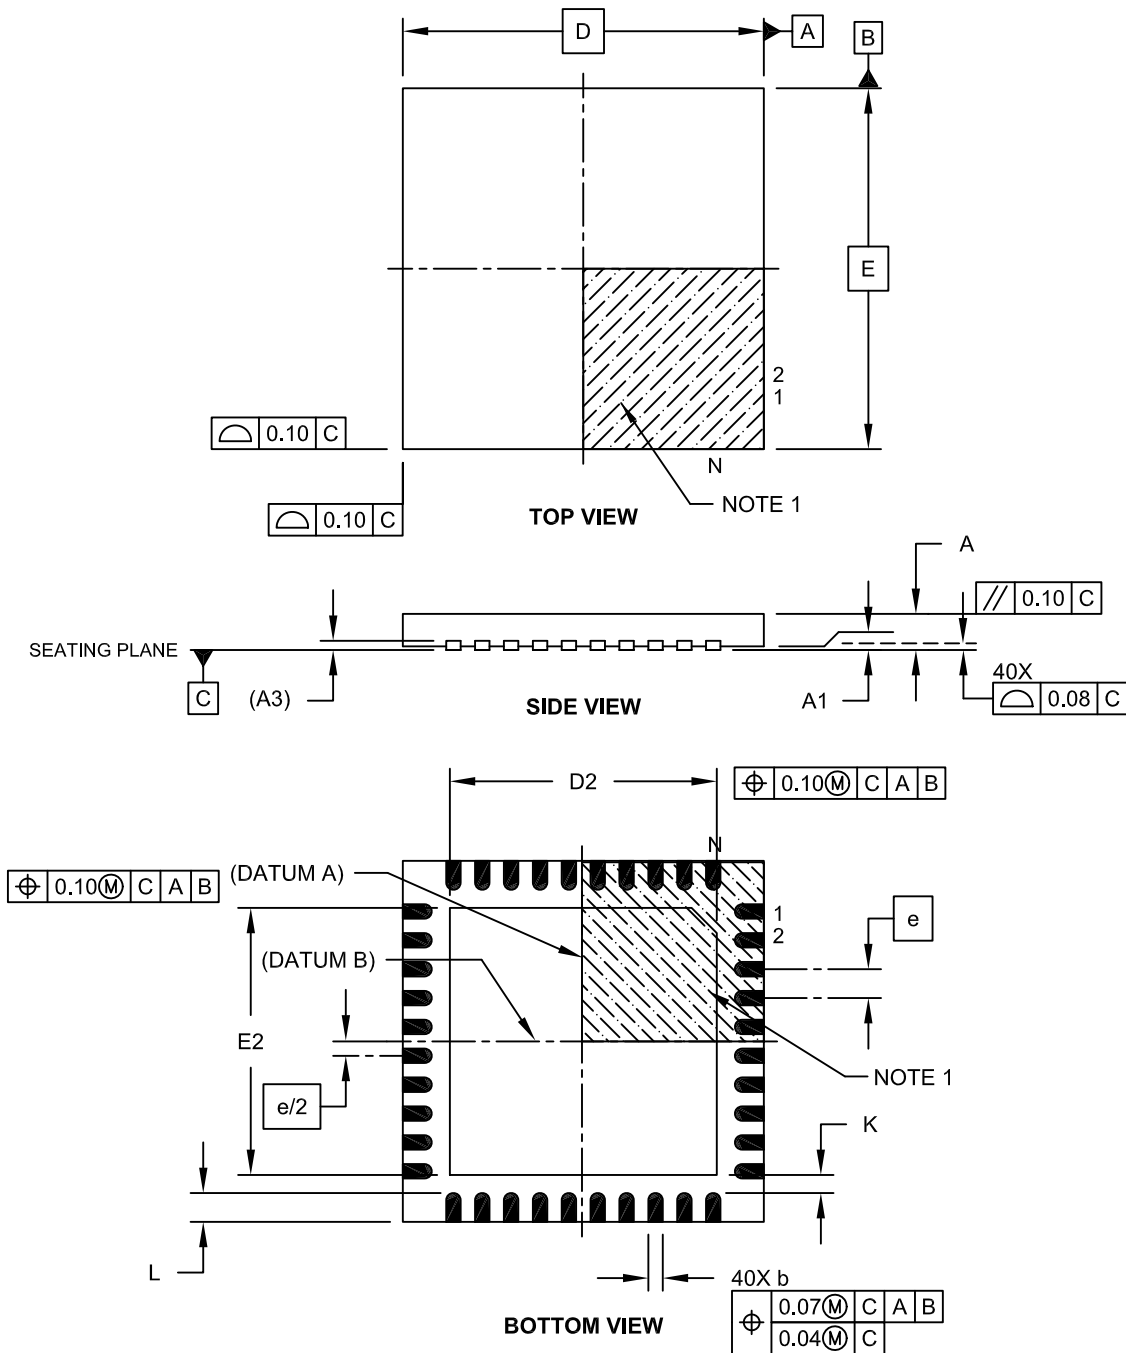
Microchip Technology Drawing C04-156A Sheet 1 of 2

40-Lead Ultra Thin Plastic Quad Flat, No Lead Package (MV) – 5x5x0.5 mm Body [UQFN]

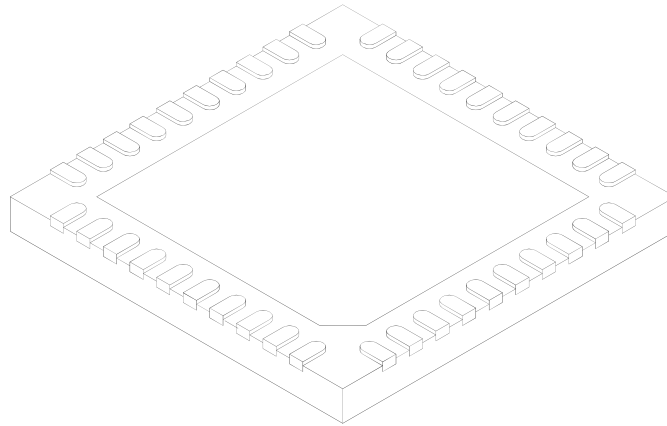
40-Lead Ultra Thin Plastic Quad Flat, No Lead Package (MV) – 5x5x0.5 mm Body [UQFN]

Units		MILLIMETERS		
Dimension Limits		MIN	NOM	MAX
Number of Pins	N	40		
Pitch	e	0.40 BSC		
Overall Height	A	0.45	0.50	0.55
Standoff	A1	0.00	0.02	0.05
Contact Thickness	A3	0.127 REF		
Overall Width	E	5.00 BSC		
Exposed Pad Width	E2	3.60	3.70	3.80
Overall Length	D	5.00 BSC		
Exposed Pad Length	D2	3.60	3.70	3.80
Contact Width	b	0.15	0.20	0.25
Contact Length	L	0.30	0.40	0.50
Contact-to-Exposed Pad	K	0.20	-	-

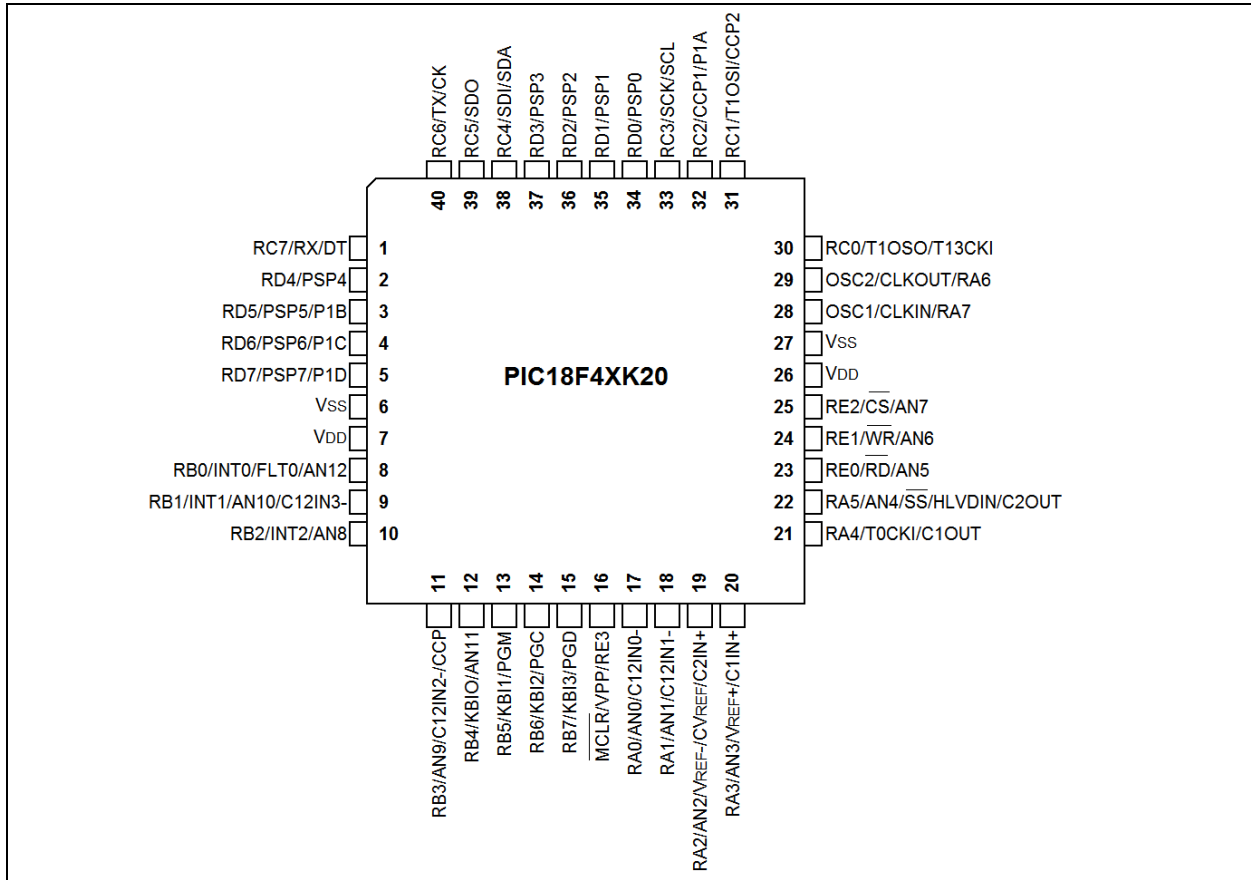
FIGURE 26-1: 40-PIN DIAGRAM UQFN

A new 40-pin UQFN diagram has been added to the data sheet (see [Figure 26-1](#)).

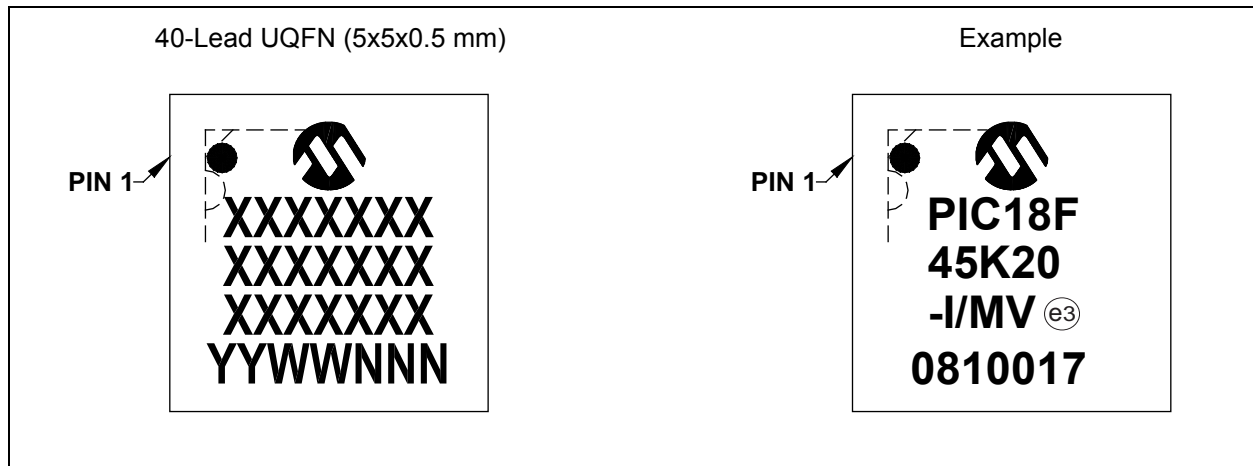
7. Module: Package Marking Information

The package marking information for the 40-pin UQFN is the following:
